COMPAGNIE INTERCOMMUNALE LIEGEOISE DES EAUX

Distribution water pollution:

Emergency Plan Management

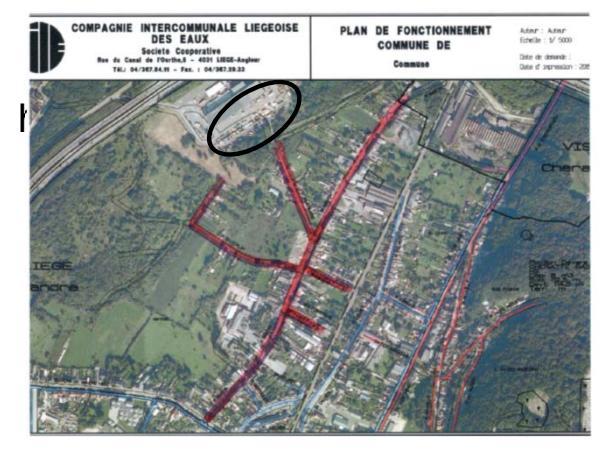
- Control of all the 218 private installations in order to find the source of the pollution. It consisted of verifying the presence of an alternative water production (rain water) and if so, the presence of the required non-return valve.
- In the evening : the source of the pollution was discovered:

An industrial customer was pumping back water from emergency tank to the CILE water network. This tank was generally fed by drinkable water, but due to significant leaks in his fire network, surface water was added to this.

The non-return valve was also absent.

- Decision to separate the connection and to seal it under the control of a bailiff.
- To date, connection returned to service after backfitting of all the technical nonconformities, but without recognition of responsability by this customer (court).
